METALLIC COATING

SUMMARY

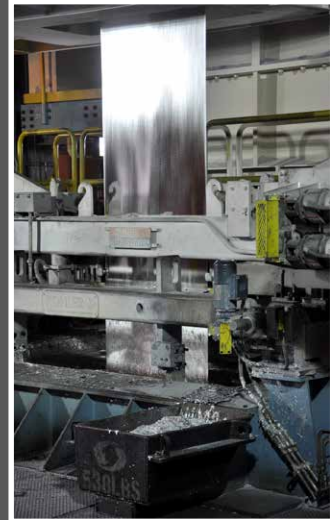
Application of the Metallic Coating
at Steelscape Kalama

The metallic coating is applied to the bare steel before it is painted. In most instances, the metallic coating is applied by passing the steel through a molten pot of the coating, after which it is cooled and treated to create a tightly bonded, consistent finish. This process is performed in accordance with ASTM standards A924, A653 and A792.

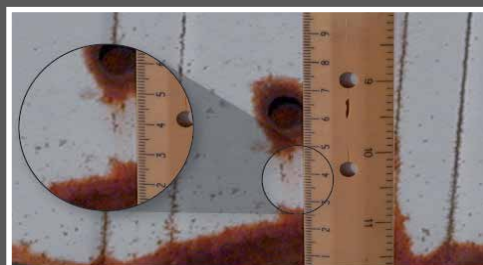
Galvanized

Corrosion comparison of a drip edge at 20 years of service life. Both products are painted and located in an acid rain environment in Pennsylvania. Note how the ZINCALUME product has slowed the spread of corrosion.
