Dissimilar Metals/Galvanic Corrosion

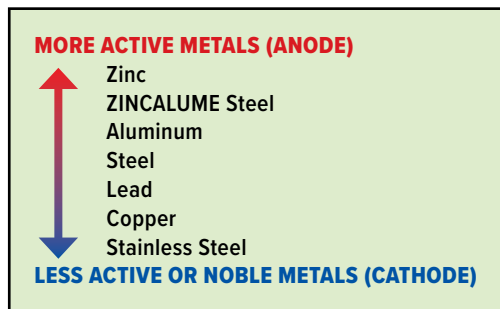
Table 1: Galvanic Series of Metallic Activity

Metals can be viewed as active or noble based on their position on the galvanic scale, simplified in Table 1 below. The further apart these metals are on this scale, the greater the potential for a reaction between the metals. In addition to the dissimilarity of the metals, the severity of the environment will influence the potential for galvanic corrosion. Common factors influencing environmental severity can include direct proximity to salt water or chemical spray, the frequency of breaking surf (which generates airborne salt-laden particulates), and how frequently the surface is rinsed by rainfall.

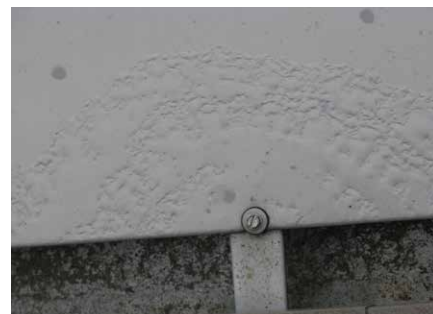
Galvanic corrosion can be caused by stainless-steel fasteners, rivets, light fixtures, window frames and other accessories recessed in metallic-coated panels in **corrosive environments**. Initially this may appear as the apparent bubbling of the painted metal roof or siding surface around the stainless-steel fixture. Often falsely identified as a paint failure, this bubbling is the steel underneath corroding, resulting in the loss of paint adhesion.

Paint bubbling radiating out from stainless steel fastener on roof 300ft from ocean.

Most stainless-steel hardware, such as clips and fasteners, are not intended to be used with ZINCALUME coated steel profiles in **corrosive environments**. In these environments stainless steel components should be used in conjunction with profiles fabricated out of aluminum.

If galvanic corrosion is identified, this issue must be rectified as promptly as possible due to the rapid rate at which it can spread. Remedies may include the replacement of the panels impacted by corrosion and the substitution or relocation of the associated dissimilar metals. For more information on the identification or rectification of galvanic corrosion, **please [contact Steelscape](#)**.

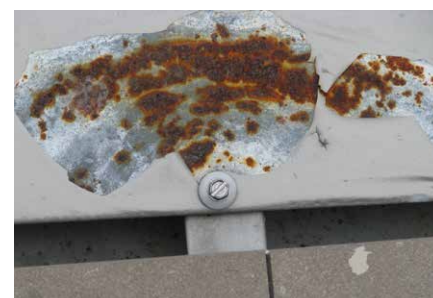
When the paint is removed corrosion down to base steel is clearly visible.
